WYOMING STATE CAPITOL REHABILITATION & RESTORATION

LEVEL I RECONNAISSANCE / LEVEL II FEASIBILITY STUDY

EXECUTIVE SUMMARY AND FREQUENTLY ASKED QUESTIONS

17 FEBRUARY 2014

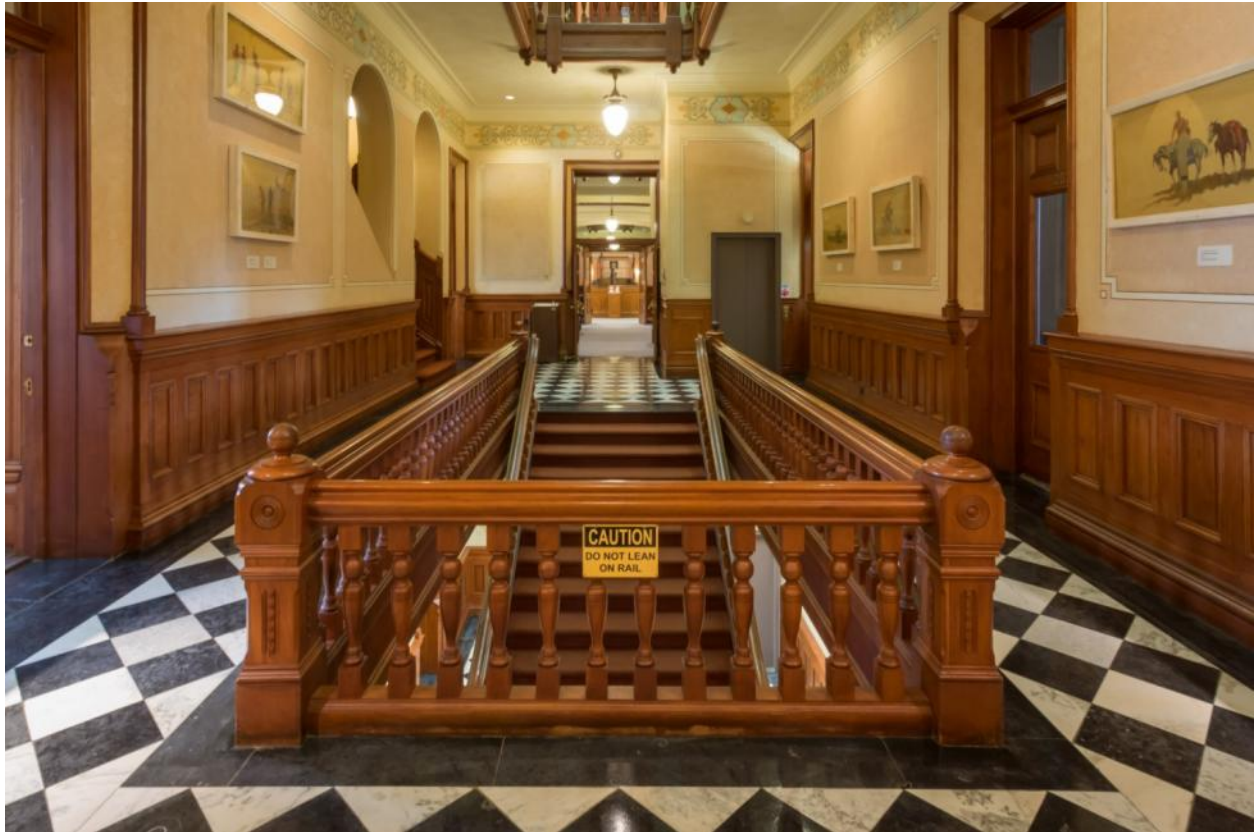
- Non – compliant exterior egress stairs
- Low railings
- Multiple ADA deficiencies at several locations
- Inadequate restrooms and related amenities

Figure 9.2: Low Railings, 2013.

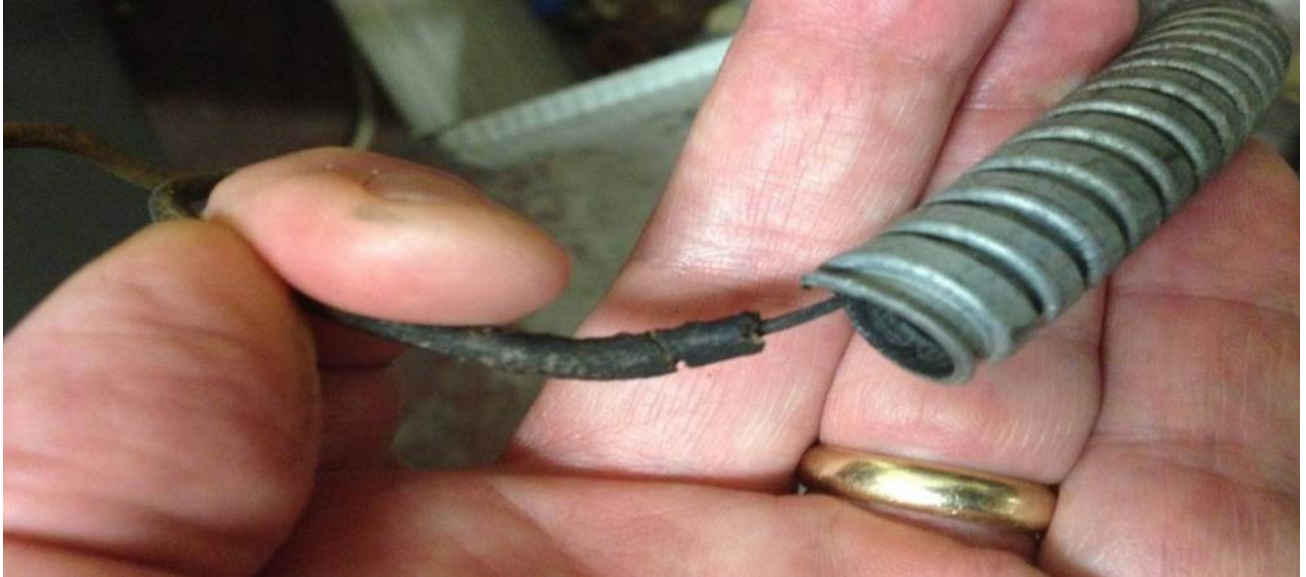
Figure 9.3: Failed Wiring, 2013.

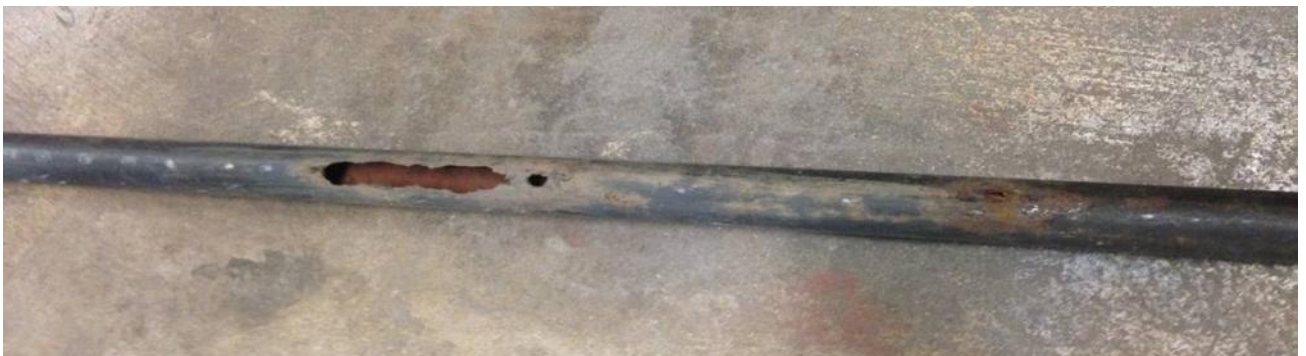
Figure 9.4: Corroded Conduit, 2013.

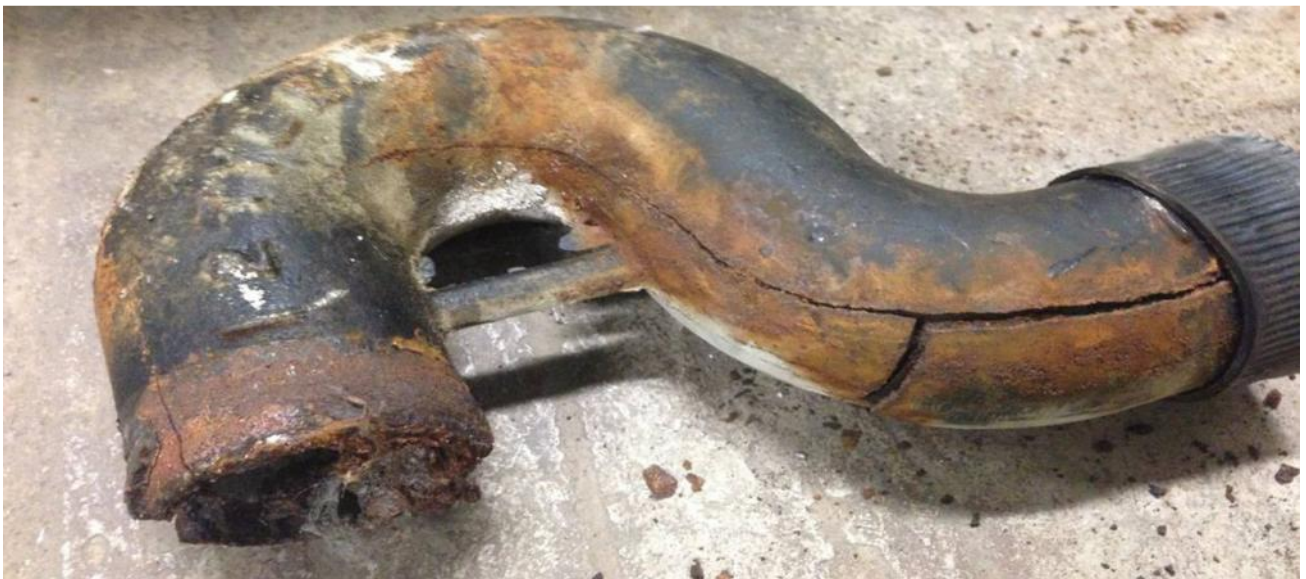
Figure 9.5: Rusty and Failed Pipe, 2013.

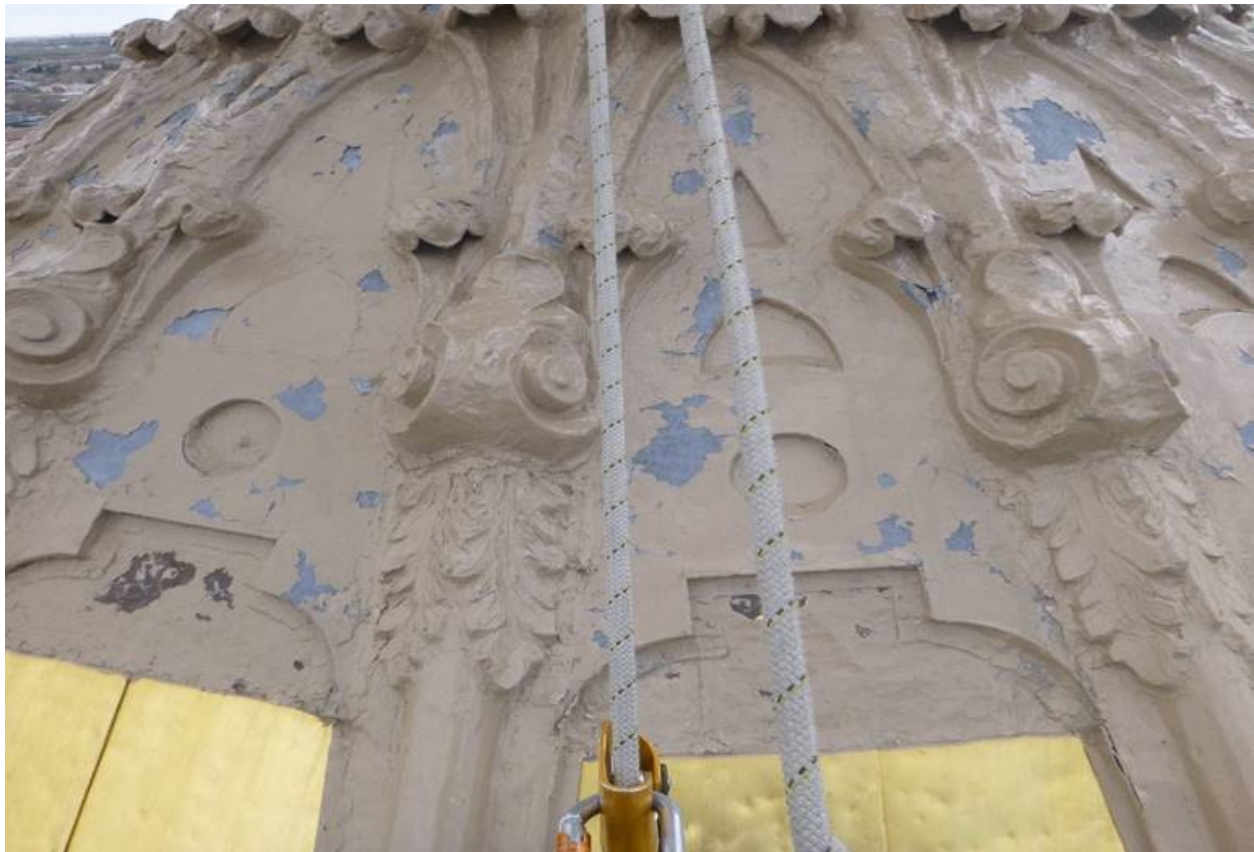
Figure 9.6: Exterior Dome, Multiple Paint Failures and Hail Damage, 2013.

- The Dome metal skin has several tears and water infiltration occurs at several locations
- Supplemental steel maybe needed to strengthen the Dome

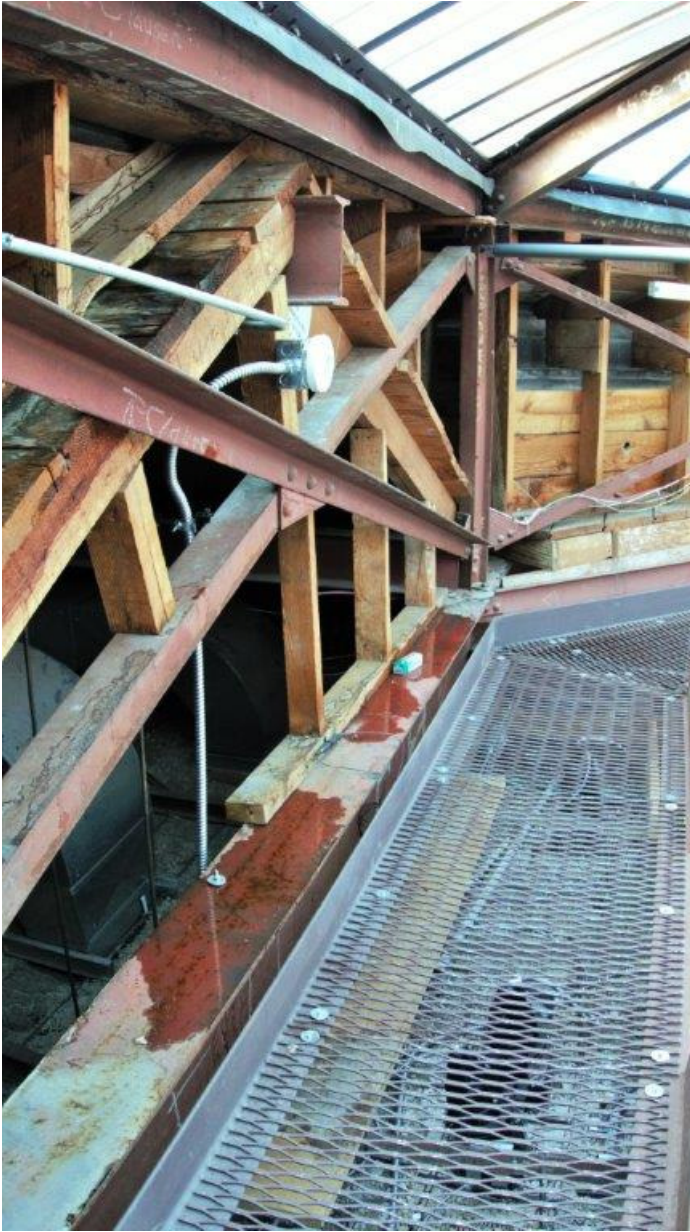
- **Water infiltration is an on-going issue**, with active leaks above the chambers, placing valuable historic building fabric, materials, finishes and murals at risk.

Figure 10.1: Water Infiltration in Attic Above Chambers, 2014.

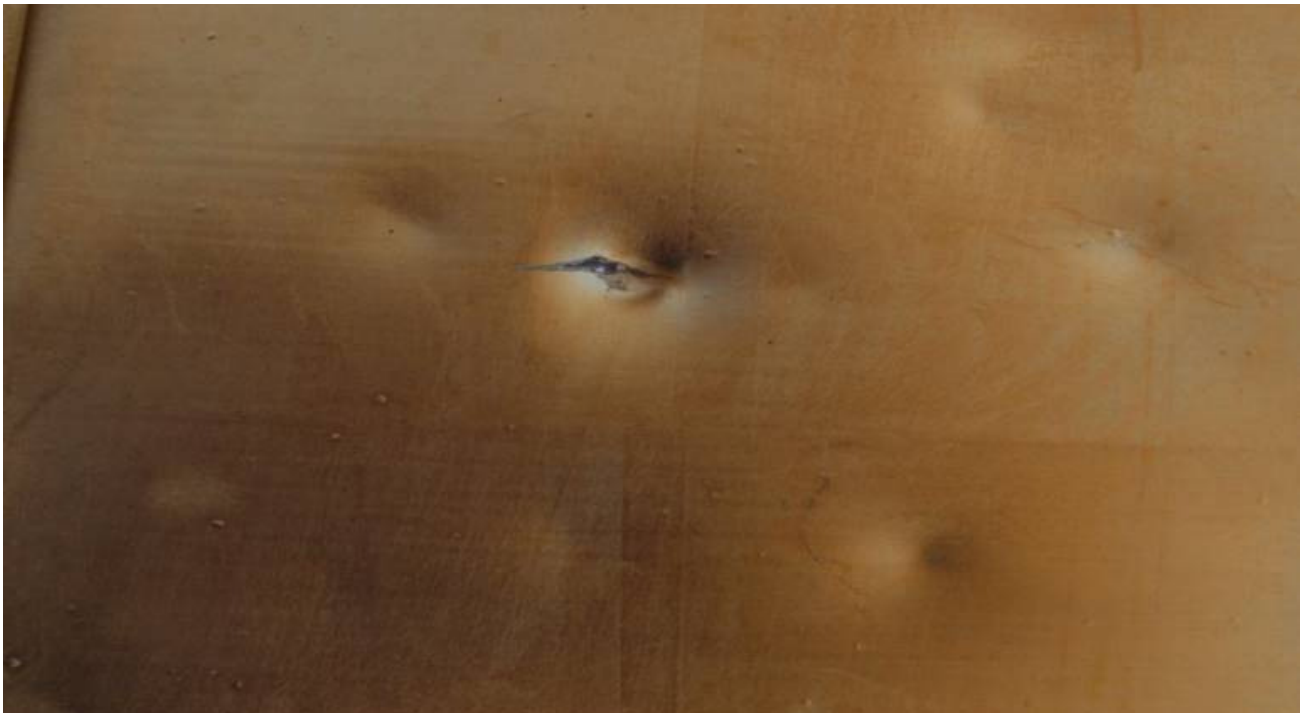
1. Coating failures over large portions of the exterior, exposing the metal to the elements.
2. Dents, tears and punctures to virtually all metal surfaces across the dome envelope, including the gilded copper panels.
3. Poor condition of the lead ornament. The temporary repairs installed in 2010 and 2011 included clear silicone sealant and automotive metal patching compound need to be removed and the area properly repaired.
4. Spot corrosion at cast iron and galvanized sheet metal elements needs to be repaired.
5. All open areas need to be repaired to prevent further moisture infiltration.
6. Moisture damage in the interior of the dome, specifically at the wood roof decking, exposed wood structural members [e.g. outriggers], and wood flooring.

Figure 11.1: One of Several Tears and Hail Damage in Dome Cladding, 2013.

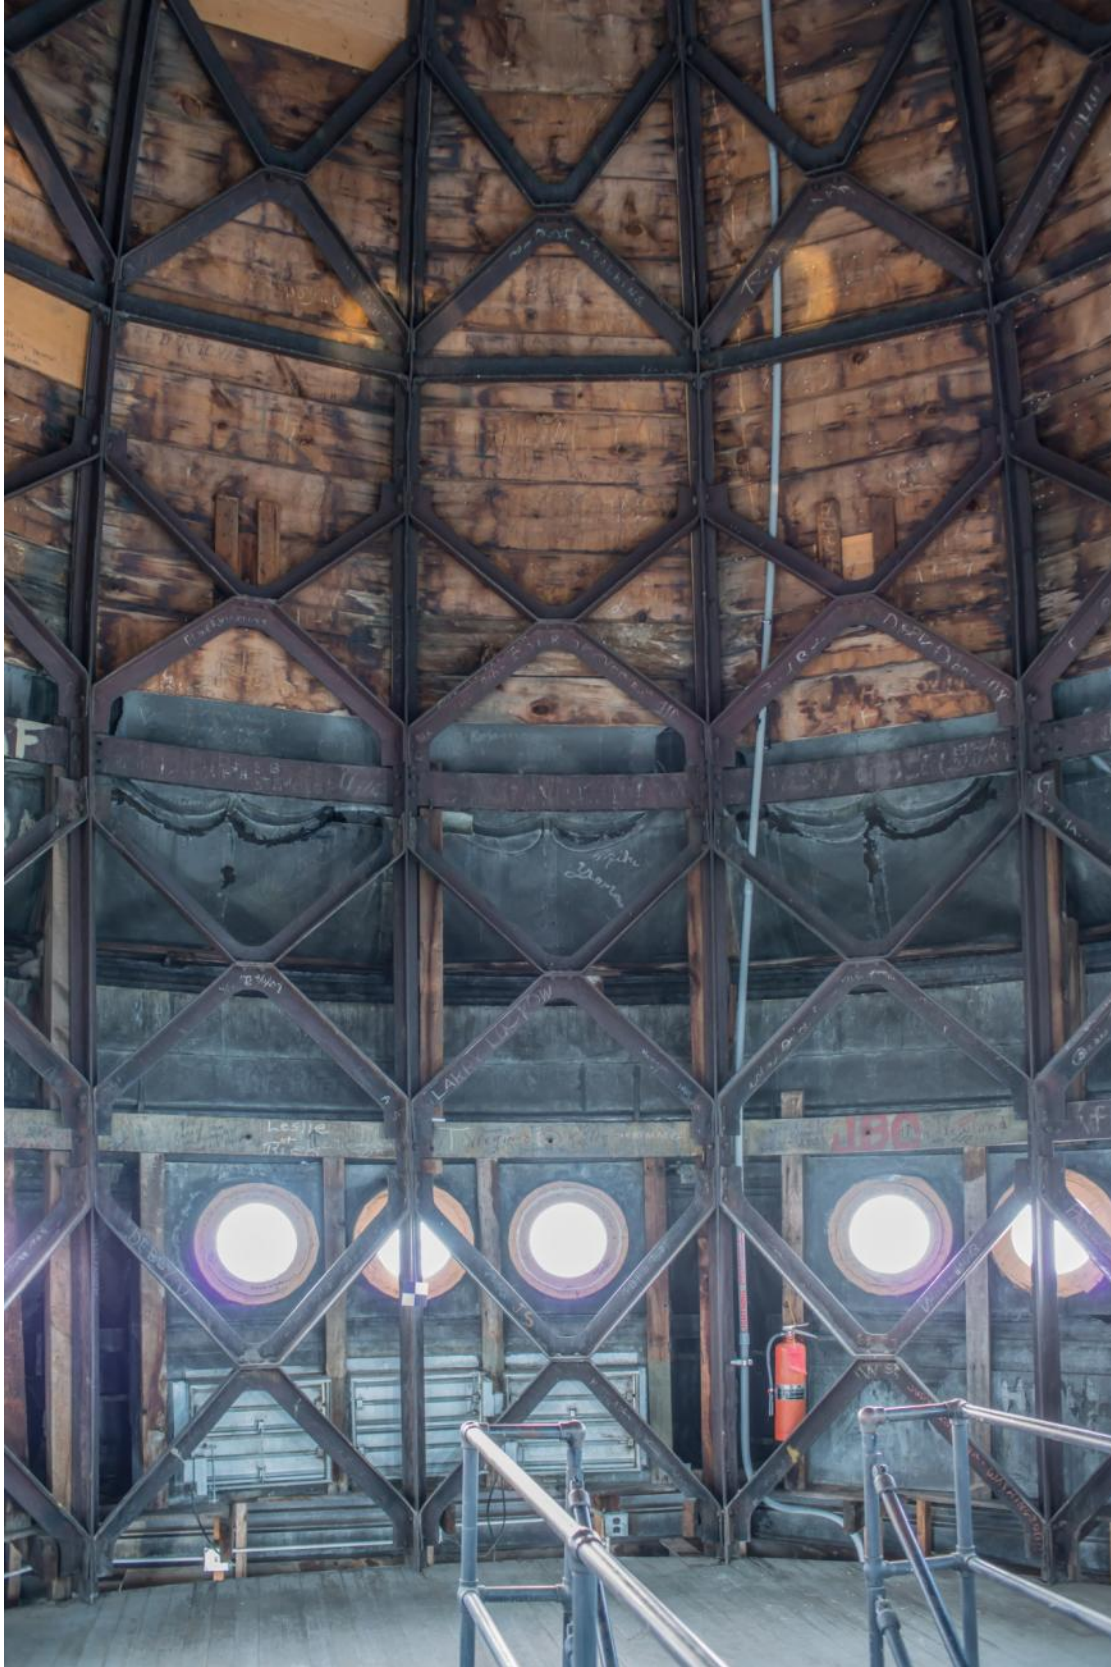
Figure 11.2: Interior Dome View, Several Areas Require Structural Repairs and Reinforcing, 2013.

The Dome's structural behavior is an important issue. The cracks that exist in the Rotunda, appear to be related to the structural behavior of the Dome. This is an important issue that needs to be addressed carefully.

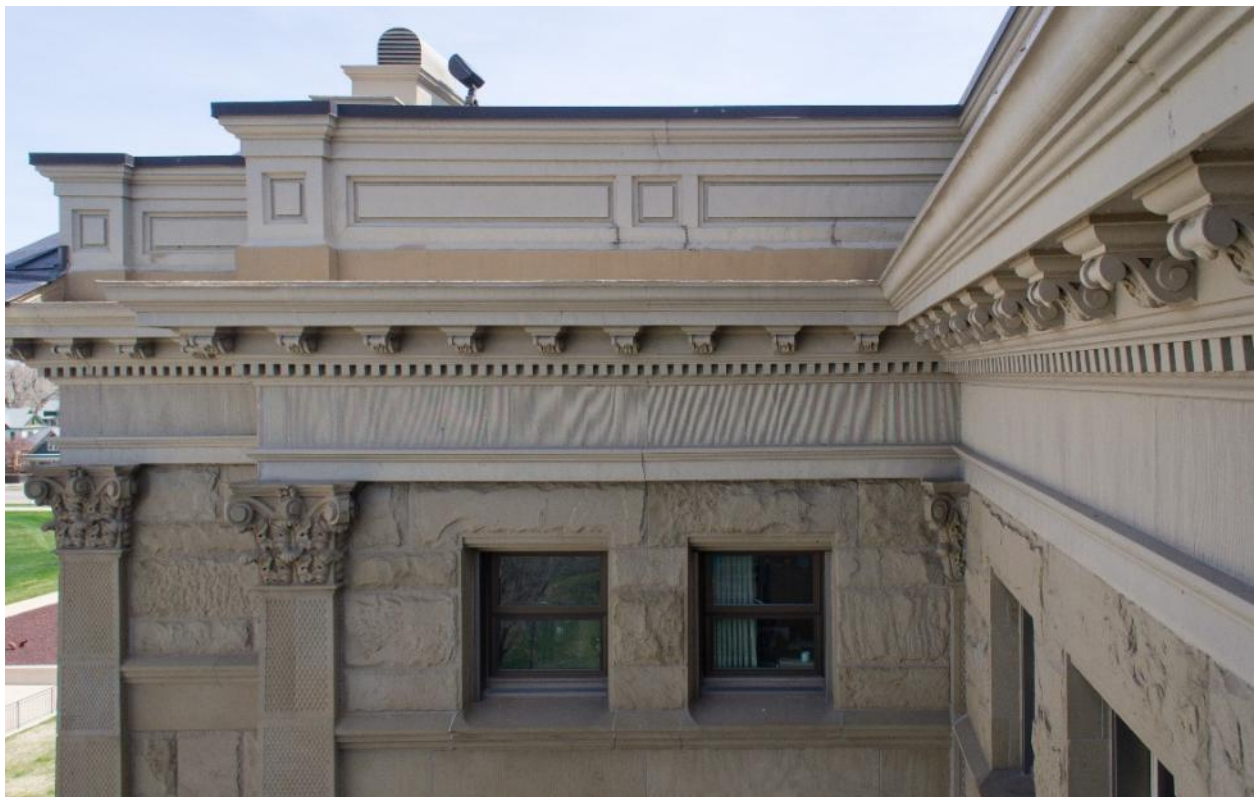
Figure 11.4: Galvanized Metal Entablature, Cornice, and Parapet Walls at the North Elevation, 2013.

While the galvanized metal appears to be in fair to good condition, there are several observations that indicate that this area needs to be repaired carefully to avoid future risk. More specifically:

1. Bent and deformed metal panels.
2. Cracked metal panels.
3. Poorly executed joints and joints that have been sealed with sealant.
4. Poorly executed repairs.
5. Peeling paint exposing the bare metal underneath.
6. It appears that a waterproofing membrane was applied to the cornice recently to protect from moisture infiltration.

The application of sealants and waterproofing membranes on metal surfaces in general has an adverse effect, i.e. opposite of the intended purpose to protect the building. Sealants on metal surfaces and waterproofing membranes tend to create separations of the paint layers below from the metal, thereby exposing the metal surfaces to the elements and making them susceptible to corrosion. This is a critical issue that needs to be addressed throughout all parapets of the Capitol.

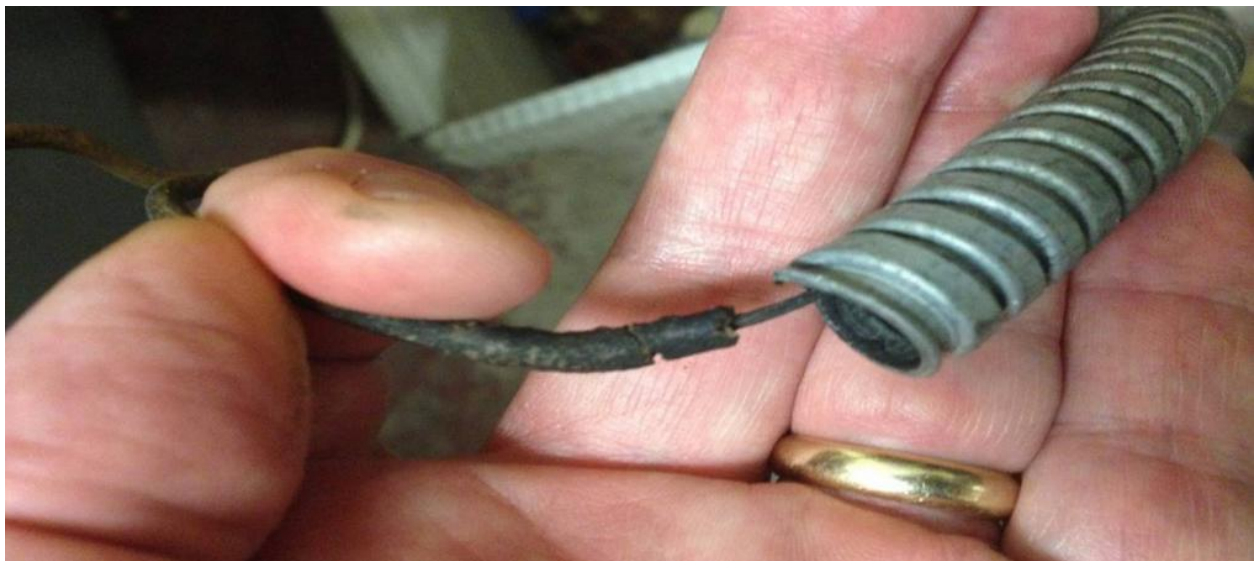
During the recent years, the Capitol has experienced failures of several electrical components, including obsolete and dangerous wiring.

Figure 12.1: Failed Wiring, 2013.

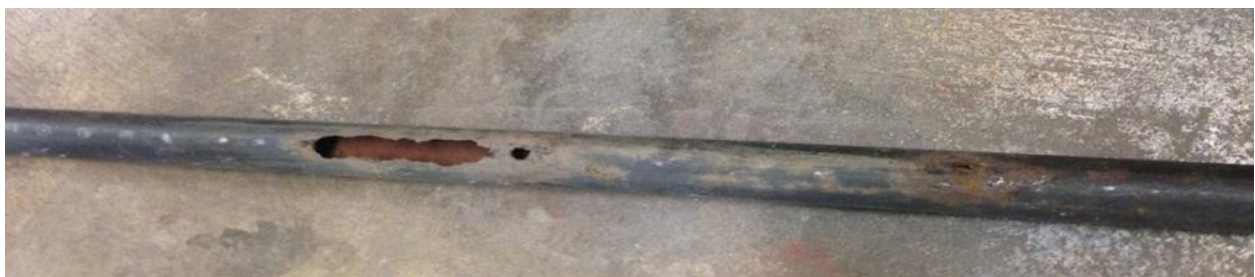
Figure 12.2: Corroded Conduit, 2013.

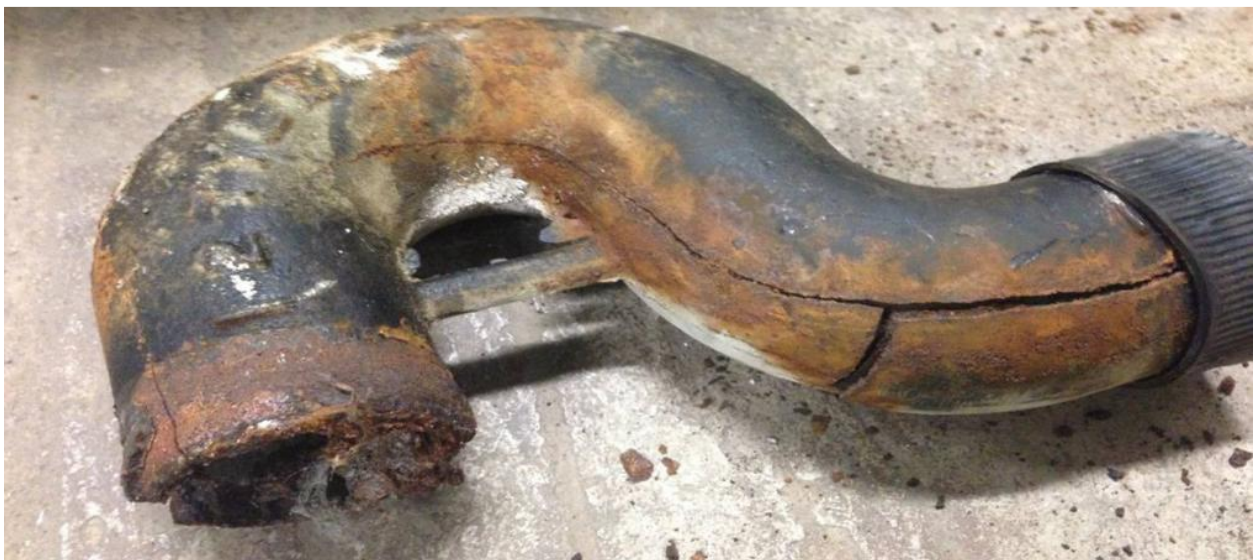
The same is true for plumbing systems where several failures have occurred in several locations of the building.

Figure 12.3: Rusty and Failed Pipe, 2013.

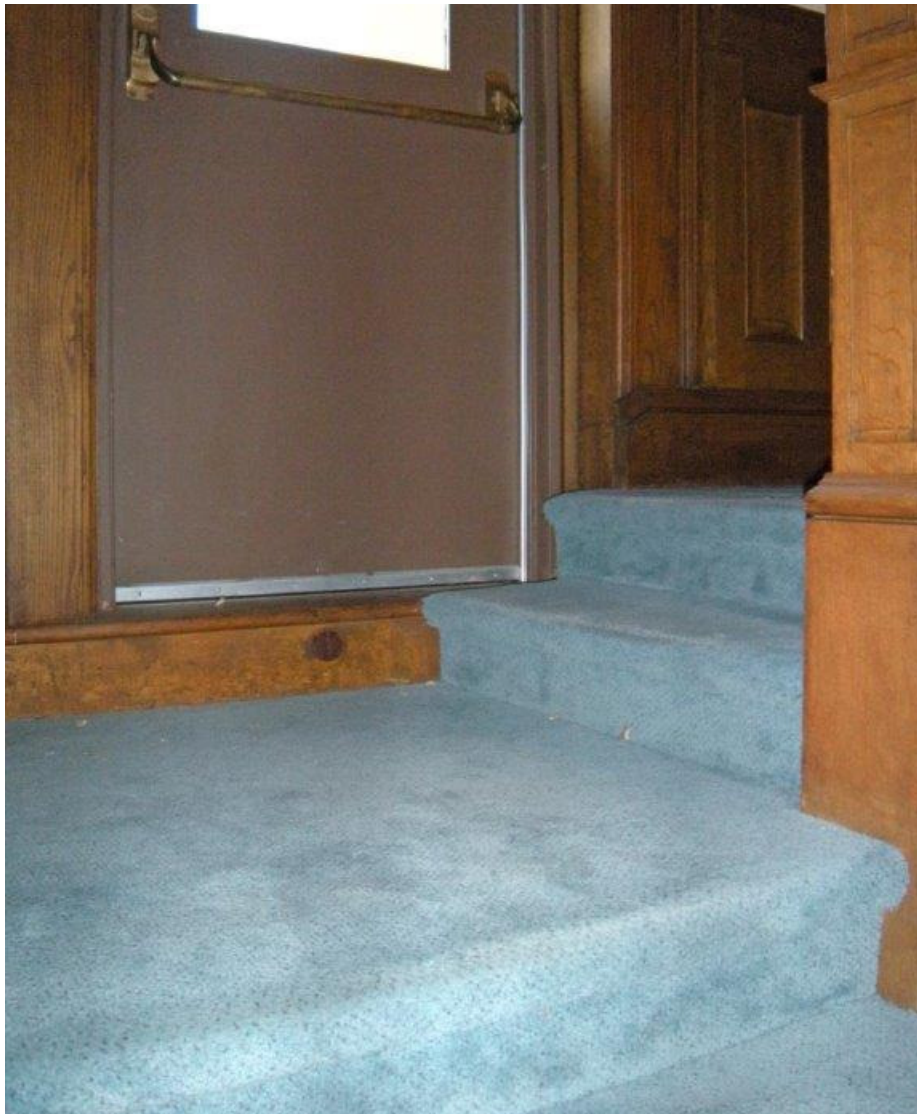
- ✓ The egress path from the third floor balcony to the stairs has potential tripping hazards.
- ✓ The stairs are not protected from the weather and during adverse weather conditions, which normally occur at peak loads during sessions, can be slippery and dangerous to use.
- ✓ The details of the stairs do not meet code in several areas.

Figure 13.2: Third Floor Egress from Chamber's Balcony; Hazardous Condition / Tripping Hazard, 2013.

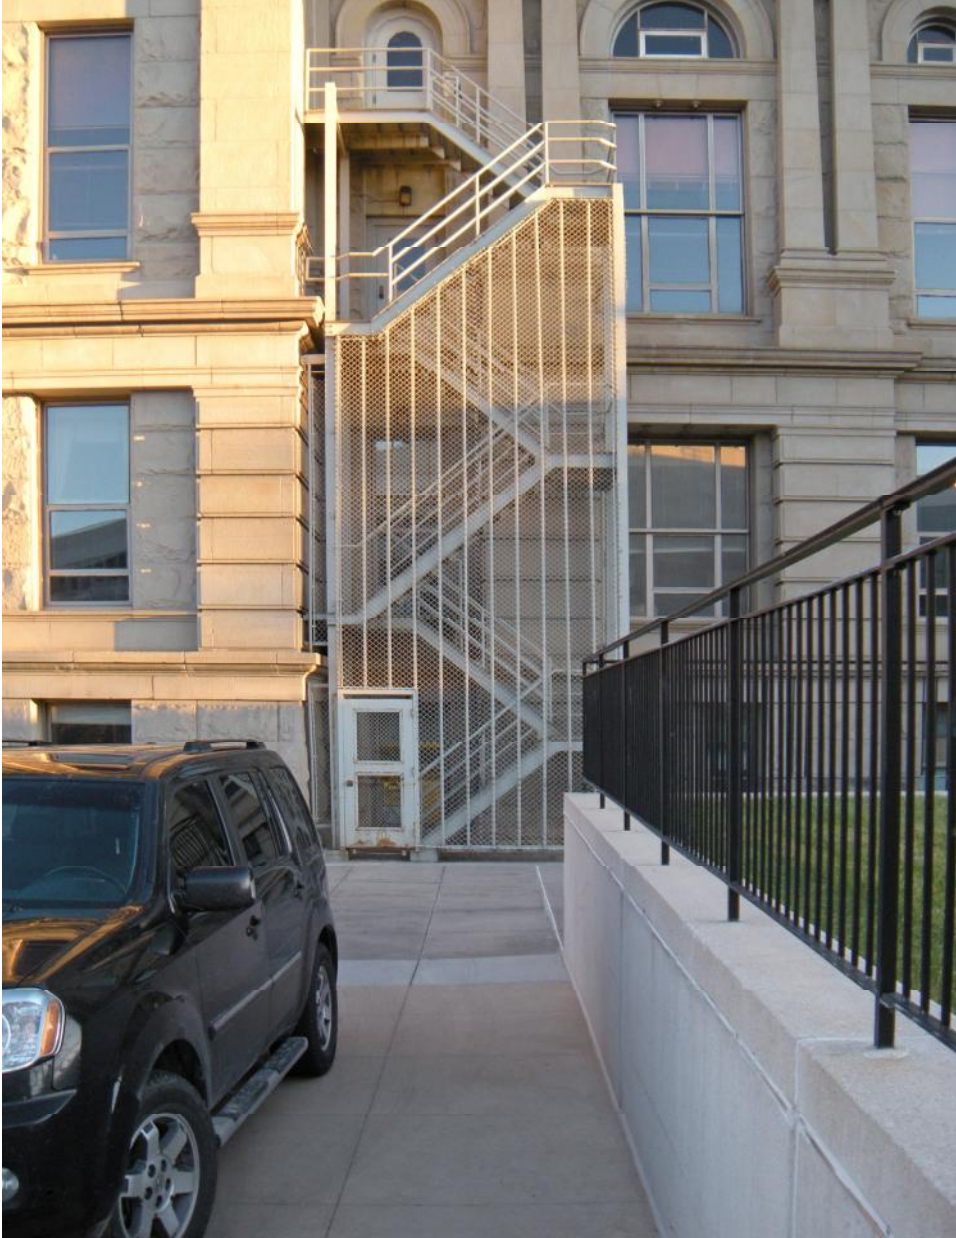
Figure 13.3: Exterior Egress Stair, 2013.

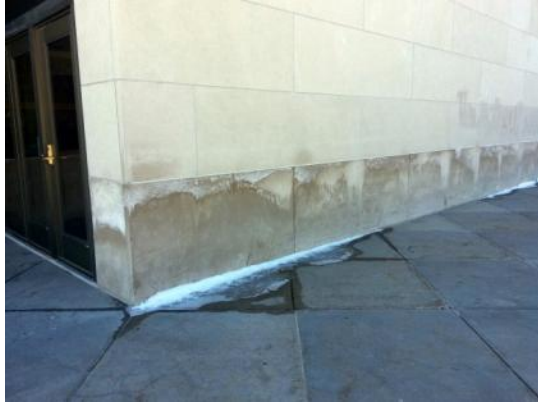
The existing exterior window system contains glass setting blocks that are in a current state of deterioration and in many cases are allowing the glazing to slide down in the window frames creating physical openings in the system allowing for outside elements such as wind, rain, and snow to penetrate the building.

View of Existing Damage, Herschler Façade

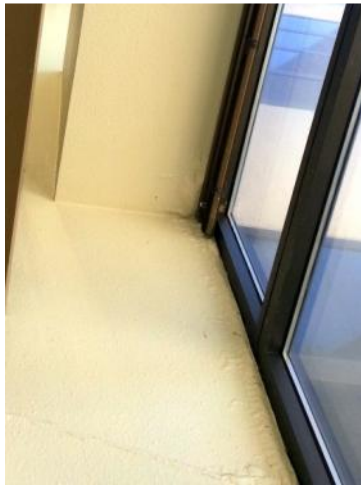
View of Existing Damage at Exterior Envelope, Herschler Façade

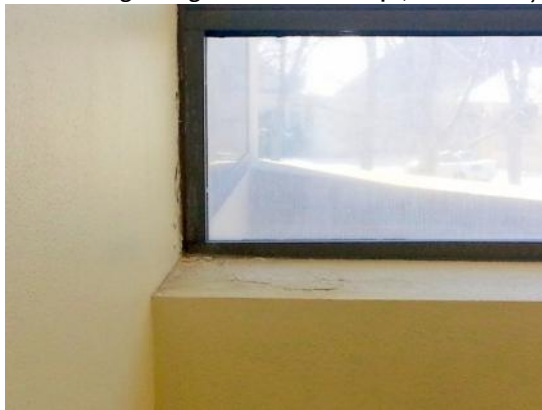
View of Existing Damage at Exterior Envelope, Herschler Façade

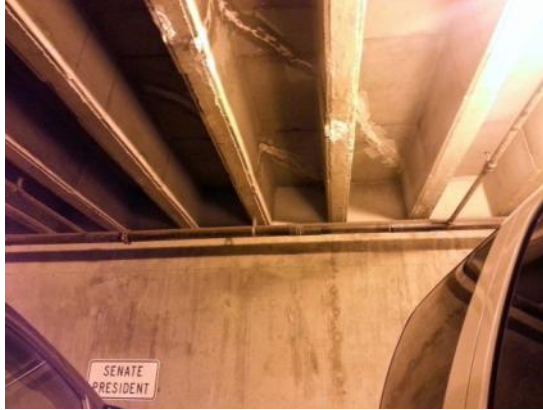
View of Damage at Existing Structural Slab Above Garage Level

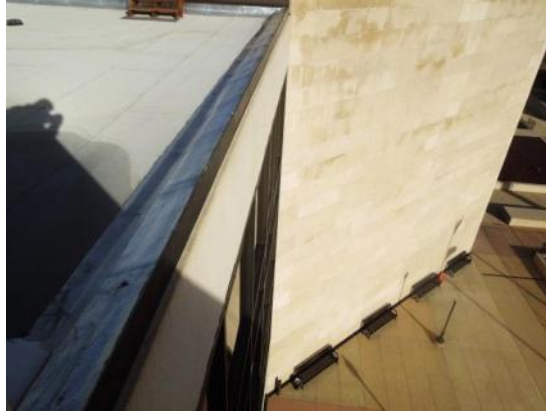
Several areas on the exterior of the building indicate a dis-coloration of the limestone and precast cladding indicating a presence of moisture. An in depth investigation is required to confirm this issue by utilizing a series of non-destructive probes to penetrate the exterior wall system for visual confirmation of the design team's concerns.

View of Potential Water Damage at Existing South Herschler Façade
